1 April 2019 to 31 March 2029

Submitted in accordance with Information Disclosure 2012

1.1. Purpose of the AMP Update

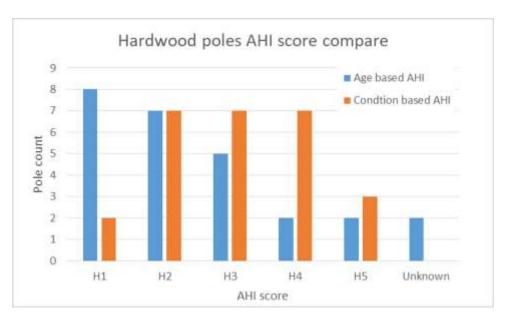
Figure 4 – Comparison of hardwood poles AHI scores for EEA's age based and condition based methodologies

Comparisons of AHI scores using both the age based and condition based methodologies have been made for other pole types also (Appendix 1). These comparisons, particularly for reinforced concrete poles for which there is a large population size, indicate that the age based methodology tends to result in lower AHI scores than the condition based methodology.
