Marlborough Lines Ltd

Asset Management Plan

March 2011

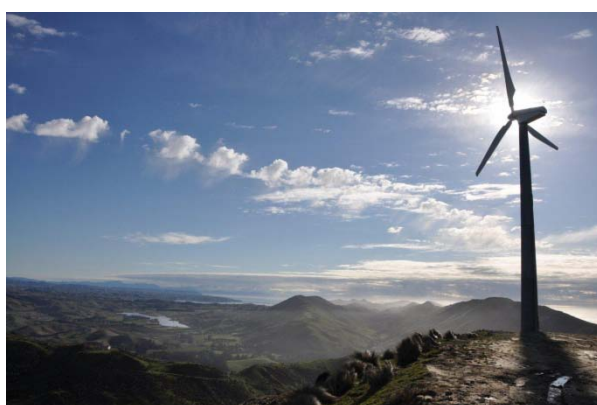
Figure 10 - Lulworth Wind Generation

Embedded generation produced a total of 10.5GWh in the 2009/2010 year and to the end of February has produced a total of 12.1GWh in the 2010/2011 year.

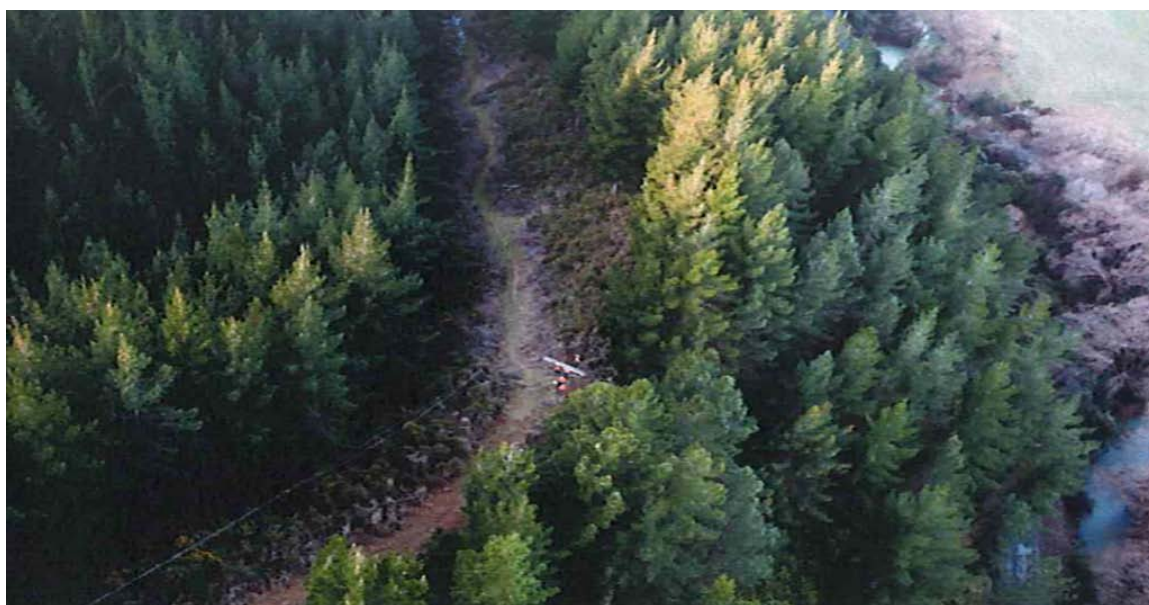
Figure 28 - 11kV Line through Plantation Forest

MLL has filed declaratory judgment proceedings with the High Court in an endeavour to further clarify several matters pertaining to the Company's responsibilities relative to the interference of trees with lines. This case is scheduled to be heard during the year and it is anticipated the outcome will advance the Company's position relative to trees.

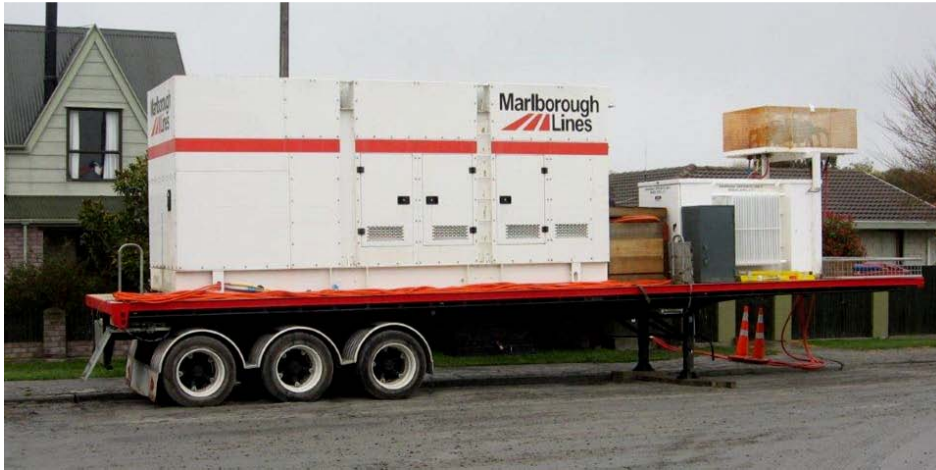
Figure 29 - 900kVA Generator in Kaiapoi (Sept 2010)

Additional mobile generators: The 900kVA and 550kVA units MLL currently owns have been very successful in reducing planned outages and maintaining supply. A further 550kVA unit will be purchased in 2011 and further mobile generation will be purchased as appropriate.
